# HP 48SX Keyboard Replacement and LCD Upgrade

## **Introduction:**

## Part 1 – Opening a Donor 48S

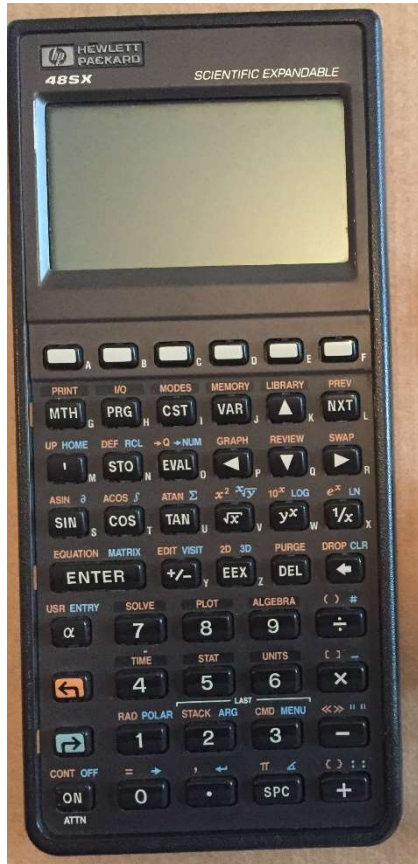
Broken 48SX Keyboard

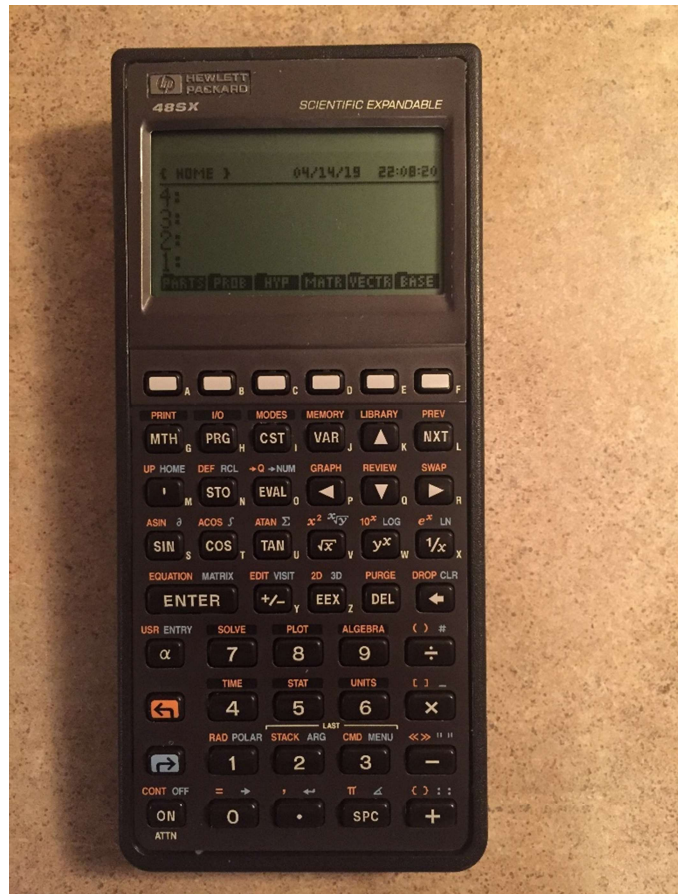
Working Keyboard and Upgraded Black LCD

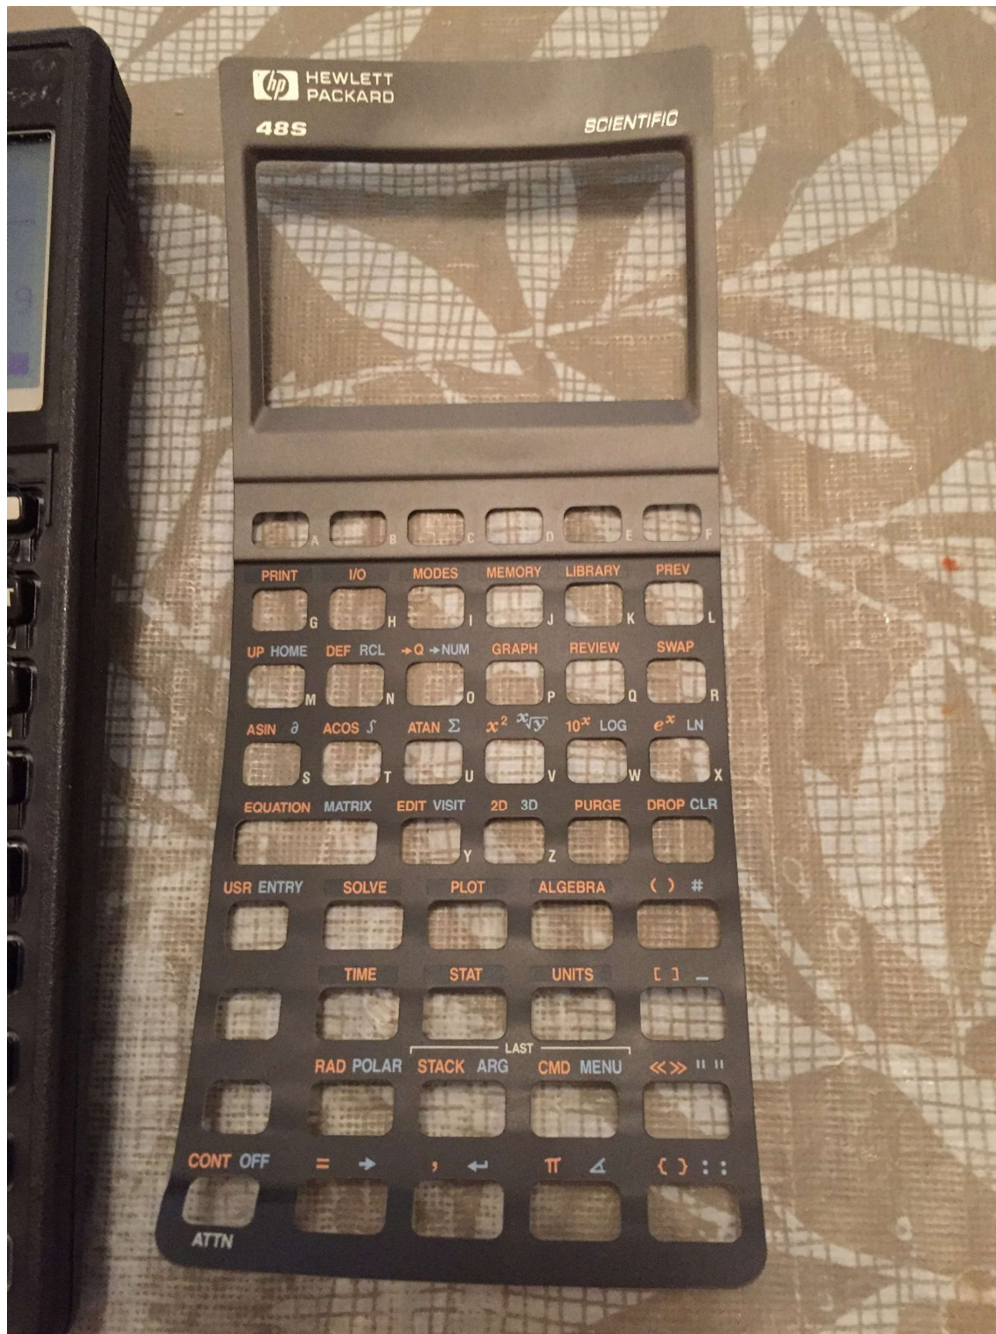
Bezel removed, and its not looking too bad in terms of creases.

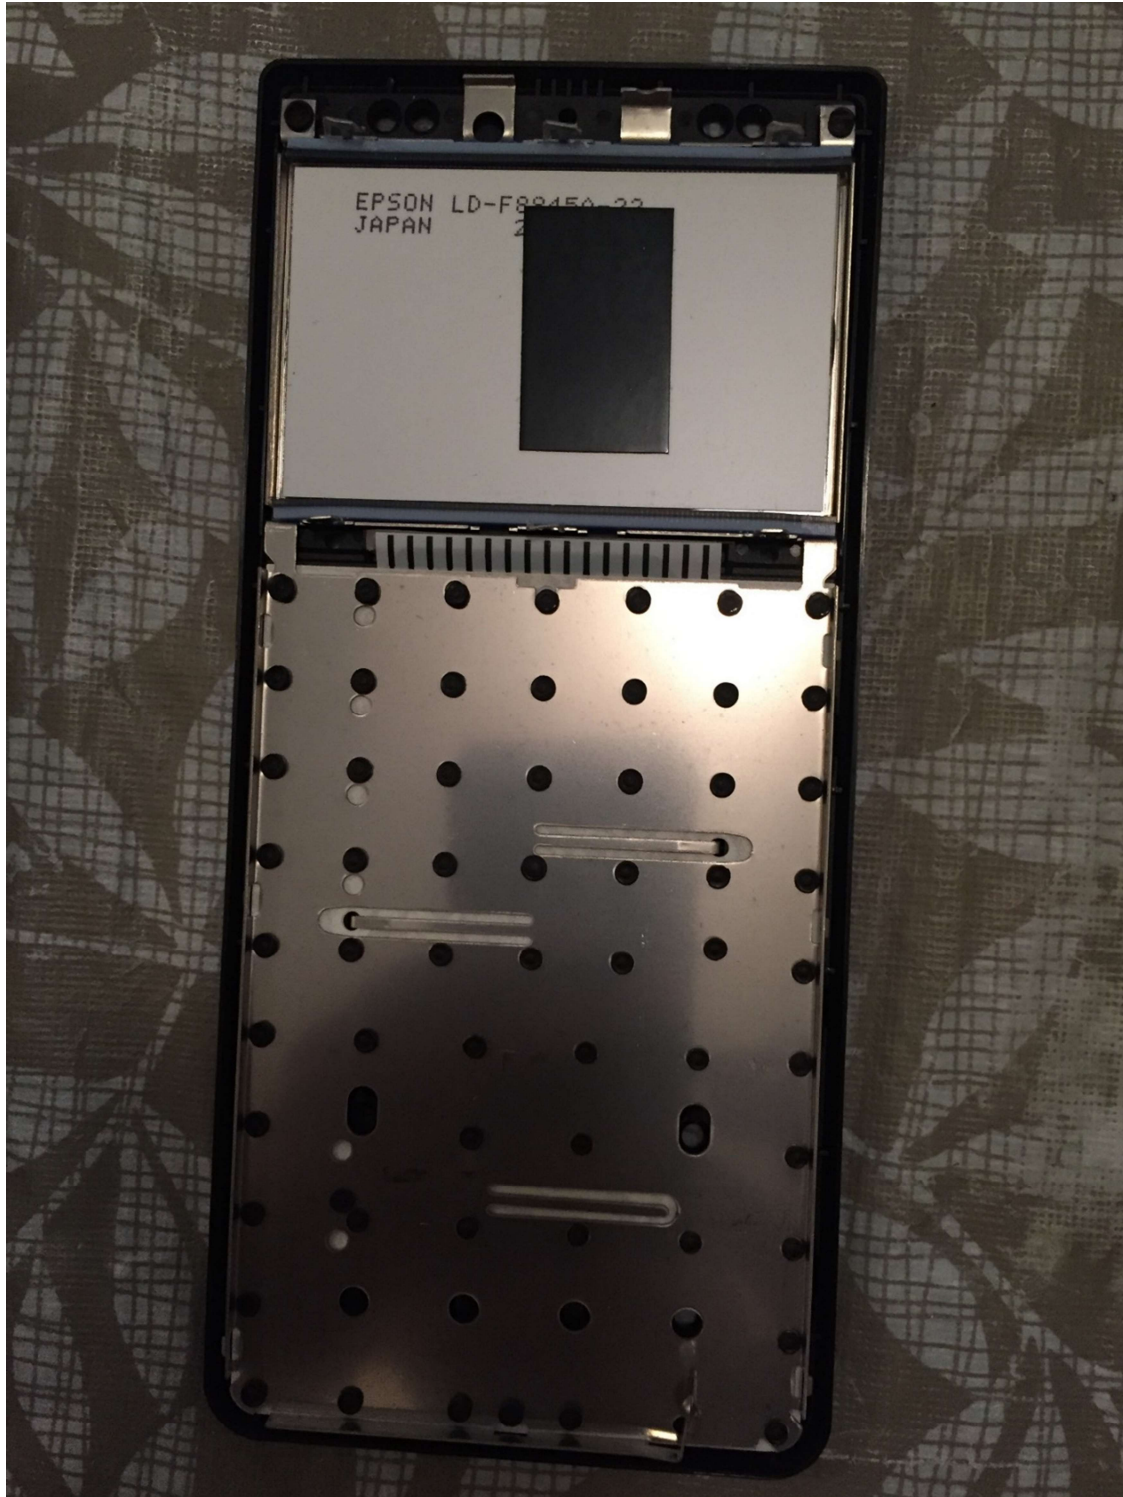
Keyboard Donor requires new keyboard foam. Also that LCD is not going to stay!!

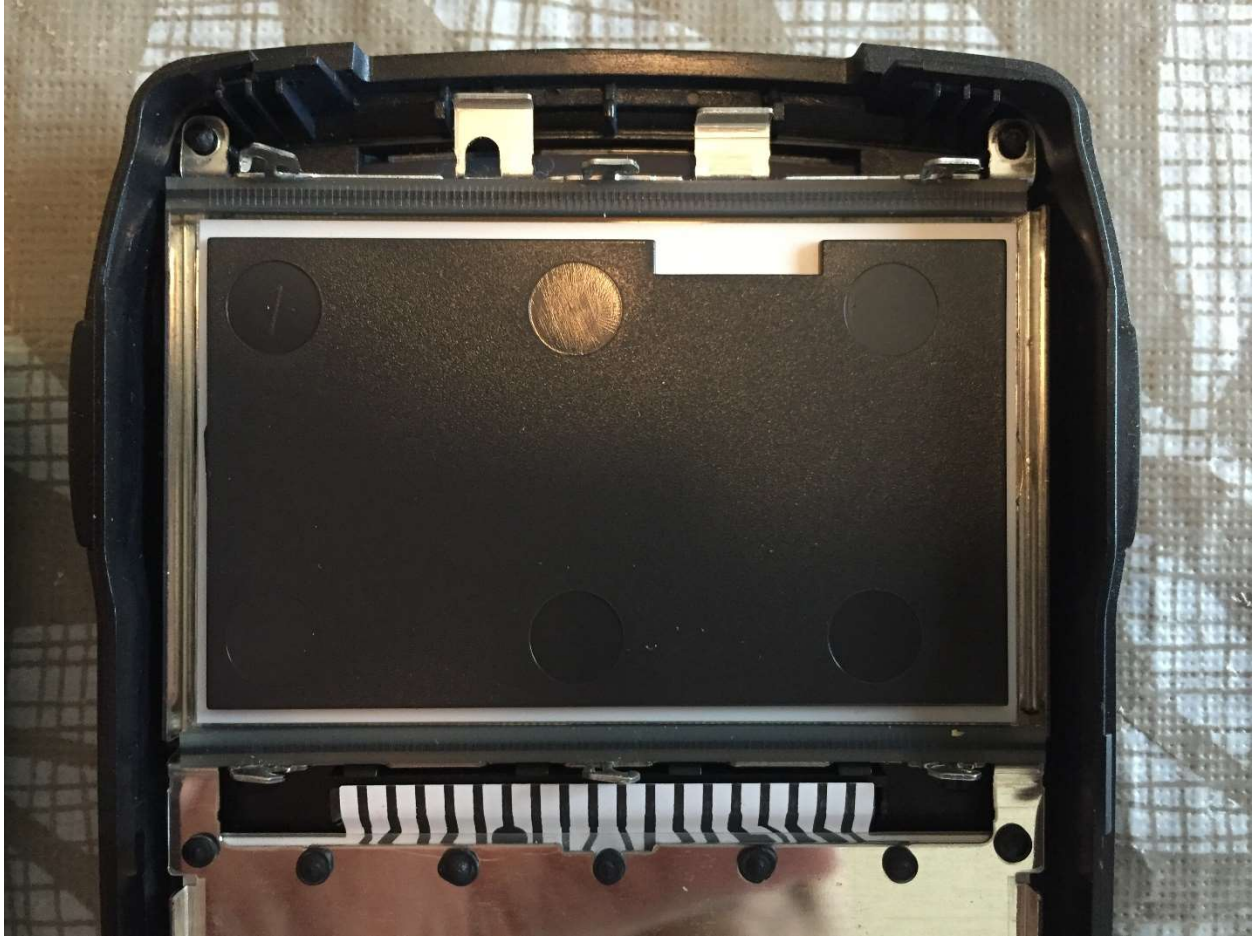
The 39G zebra strips are wider than on the 48SX, and the LCD is backed by a black plate of plastic.

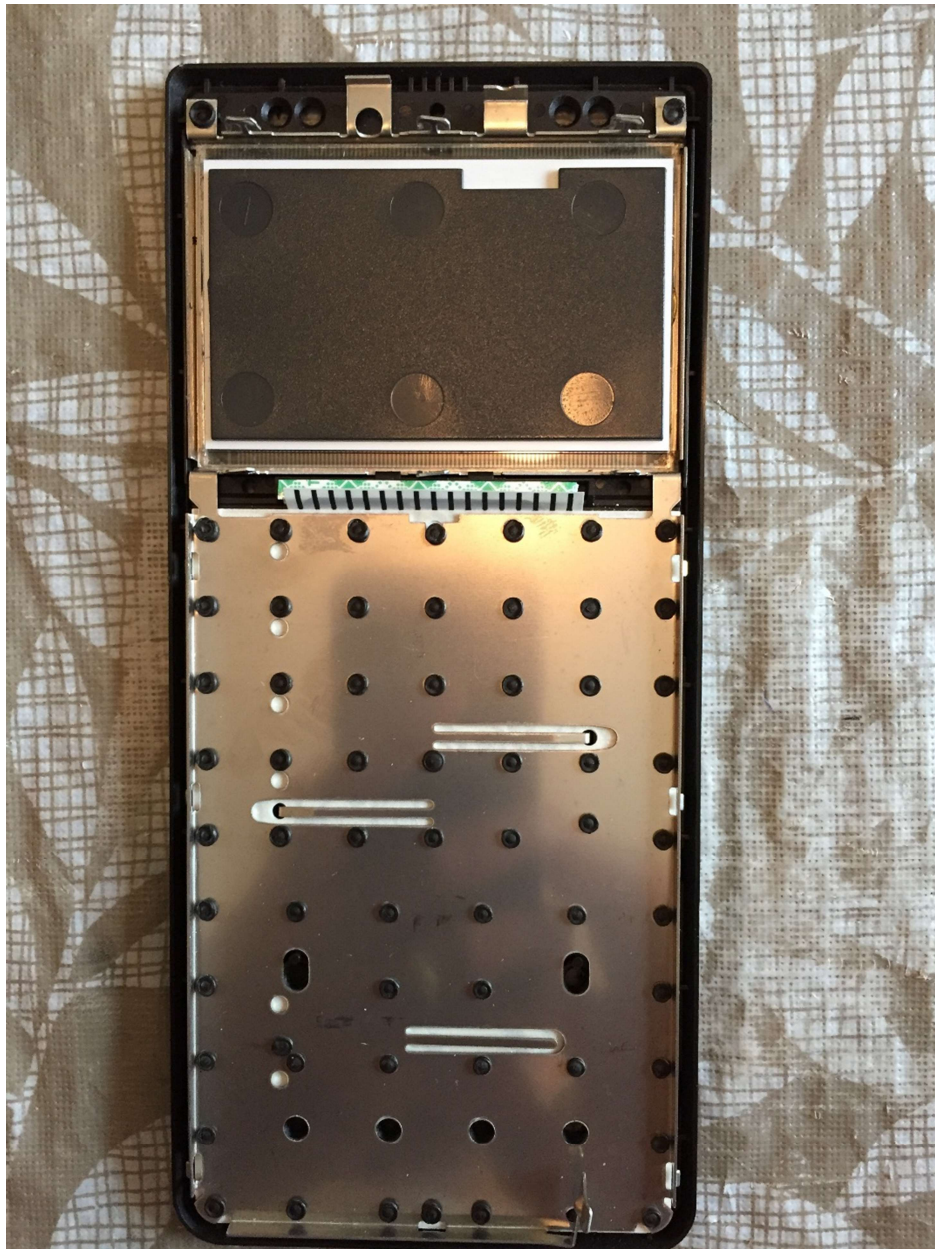
LCD has been transplanted into the 48 donor keyboard!!

Try to position it centred in the LCD frame as much as possible. You can fine tune the position after testing operation (see mention of this later on).

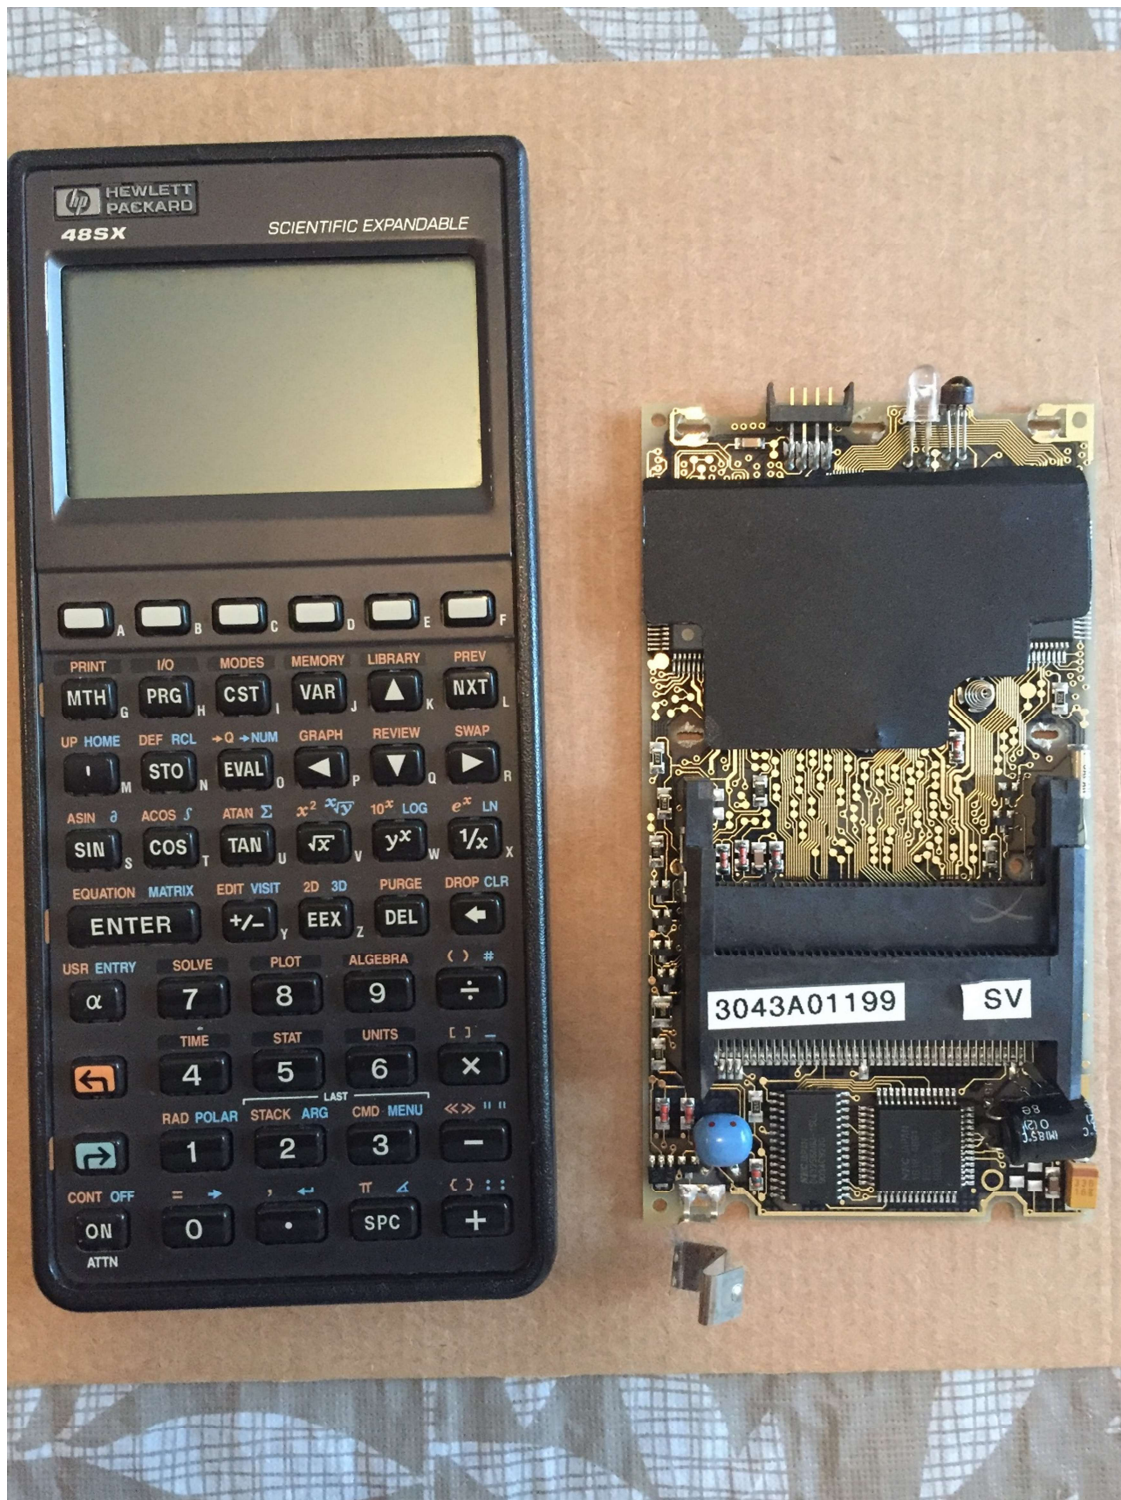
The front of my own 48sx and its PCB. The Enter key has a broken hinge, and the ON key does not work electrically anymore. It has been sitting in a case for many years now. I will end up with a Frankenstein unit consisting of my own 48sx overlay, its PCB and back case, a 39G LCD and a 48S keyboard.

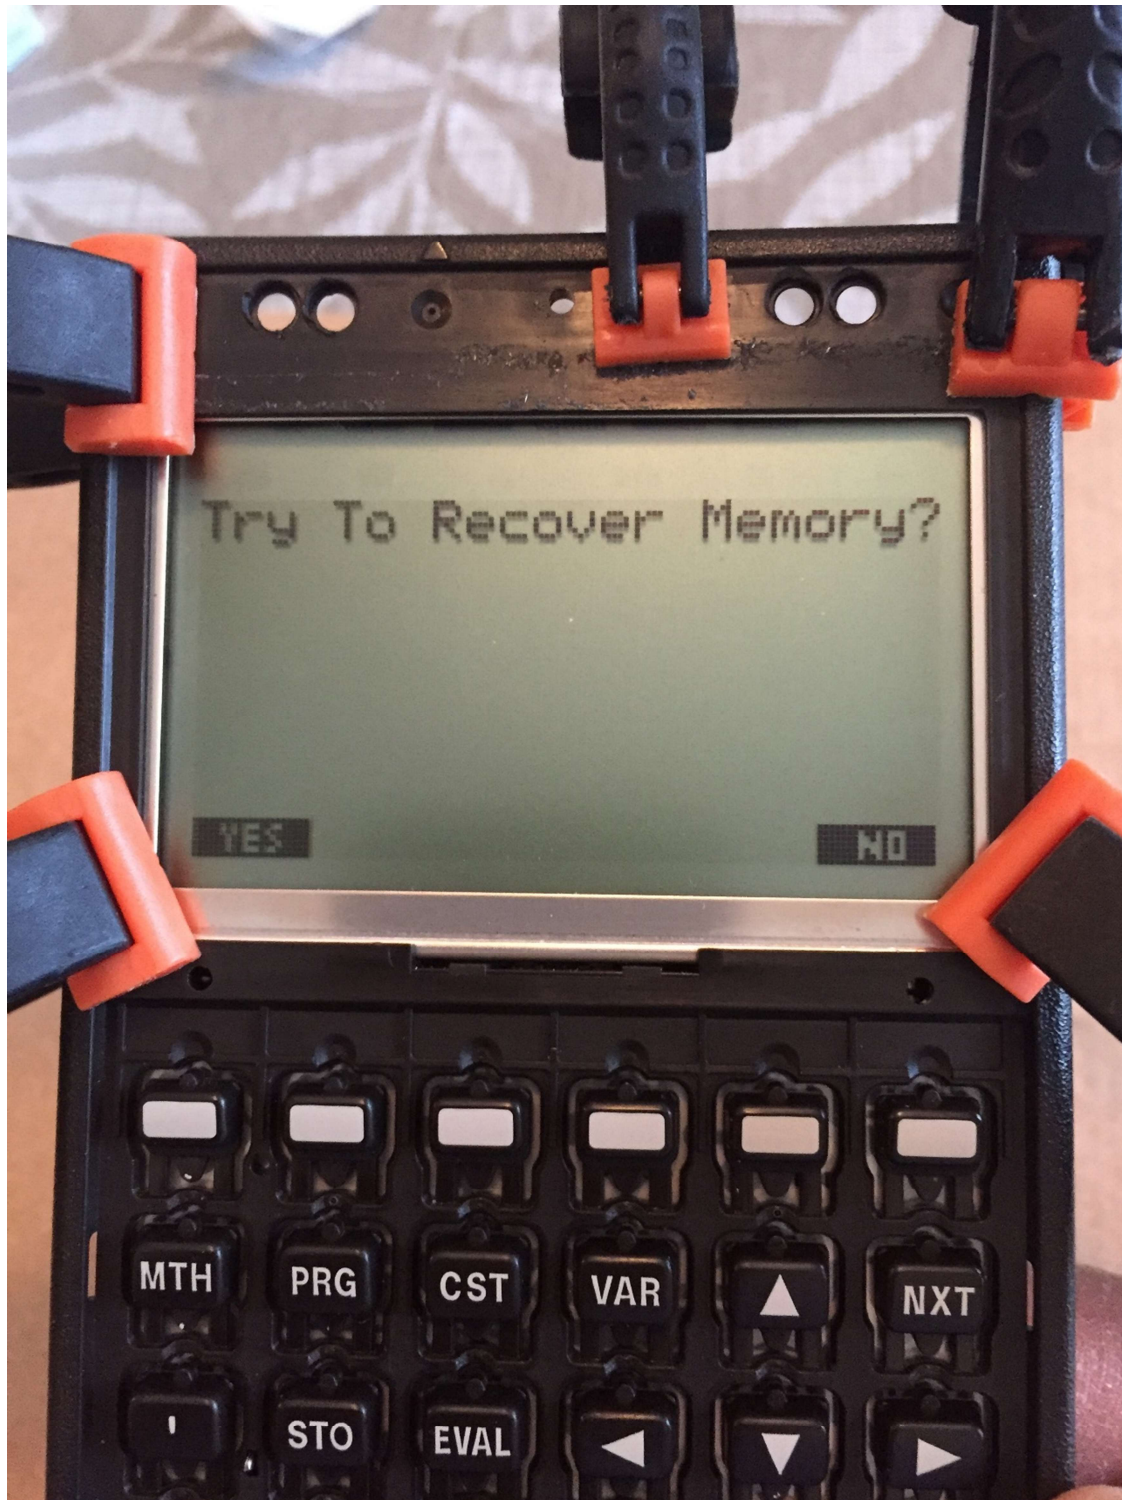
I placed my PCB in the calculator and used the clamps to hold it in place. The very first power on gave me some unexpected lines, and lit up annunciators. I was discouraged. But I removed the PCB and gently aligned the LCD from left to right in the LCD frame in the hopes of aligning the contacts correctly. The result on the next power up was a success as you can see above. Use alcohol to ensure clean contacts on the LCD, zebra and PCB contacts.

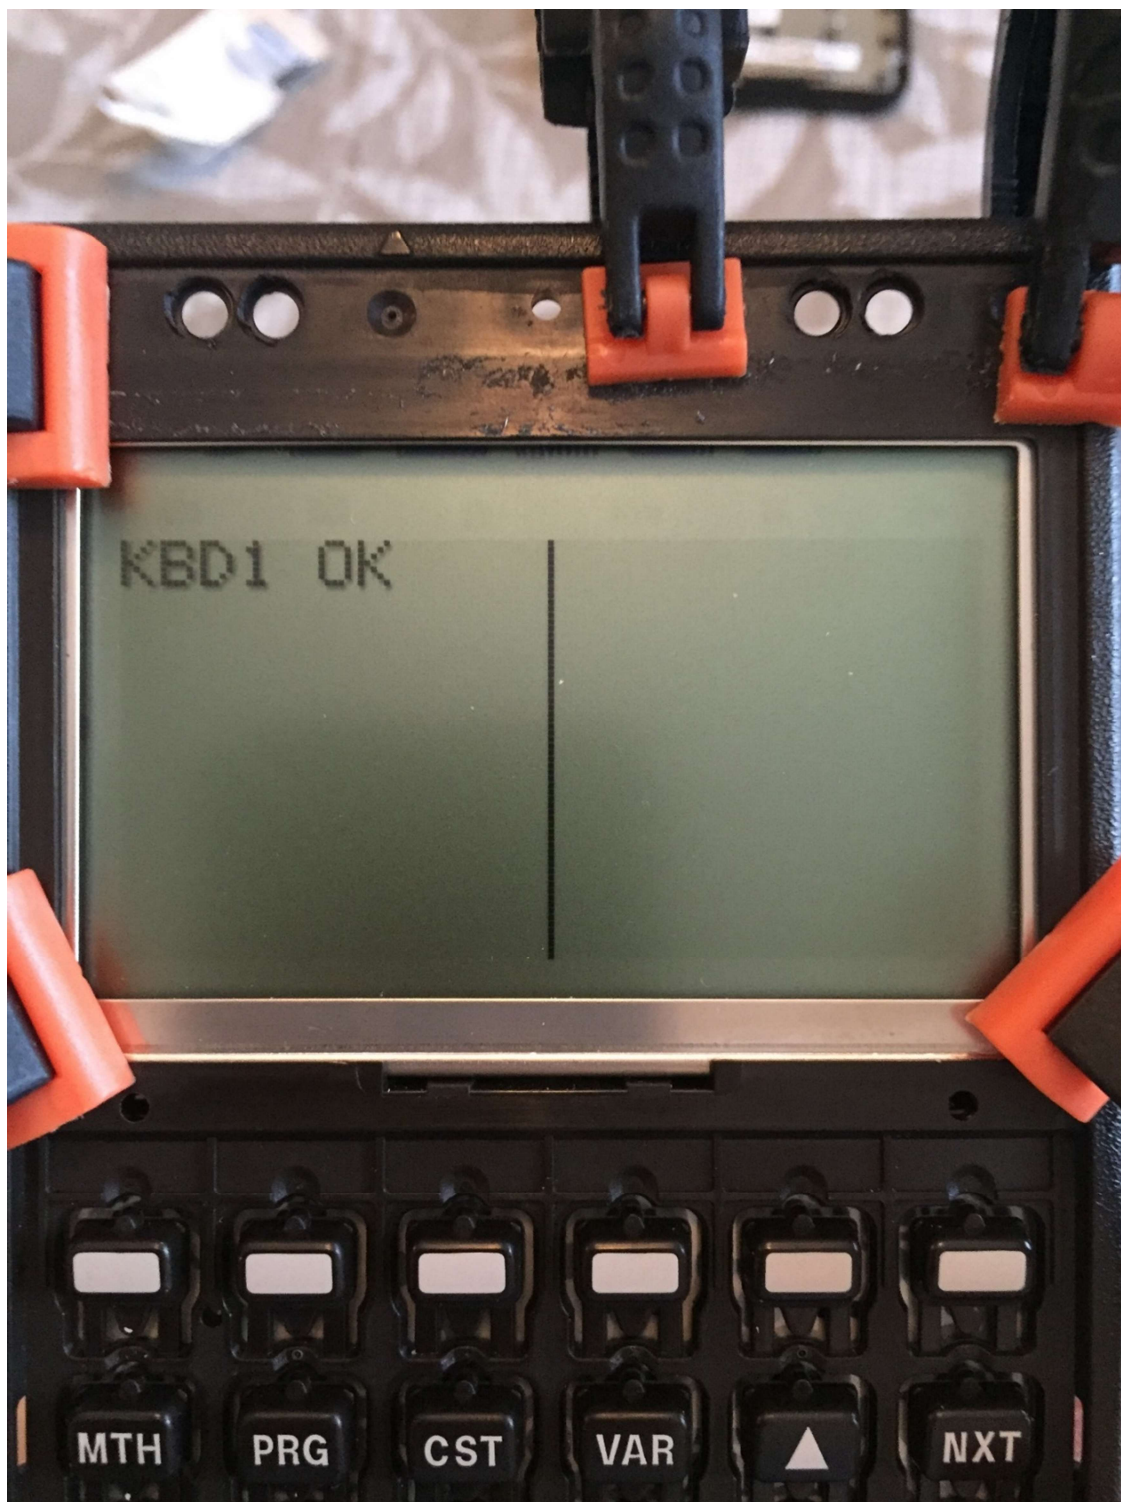
Keyboard self test passes!!

I believe the use of clamps such as these is essential for verification prior to retwisting the twist tabs. Those are pretty delicate, and if you have to realign the LCD, or clean dust on the zebra, etc, you will thank yourself for using clamps to get it all right.

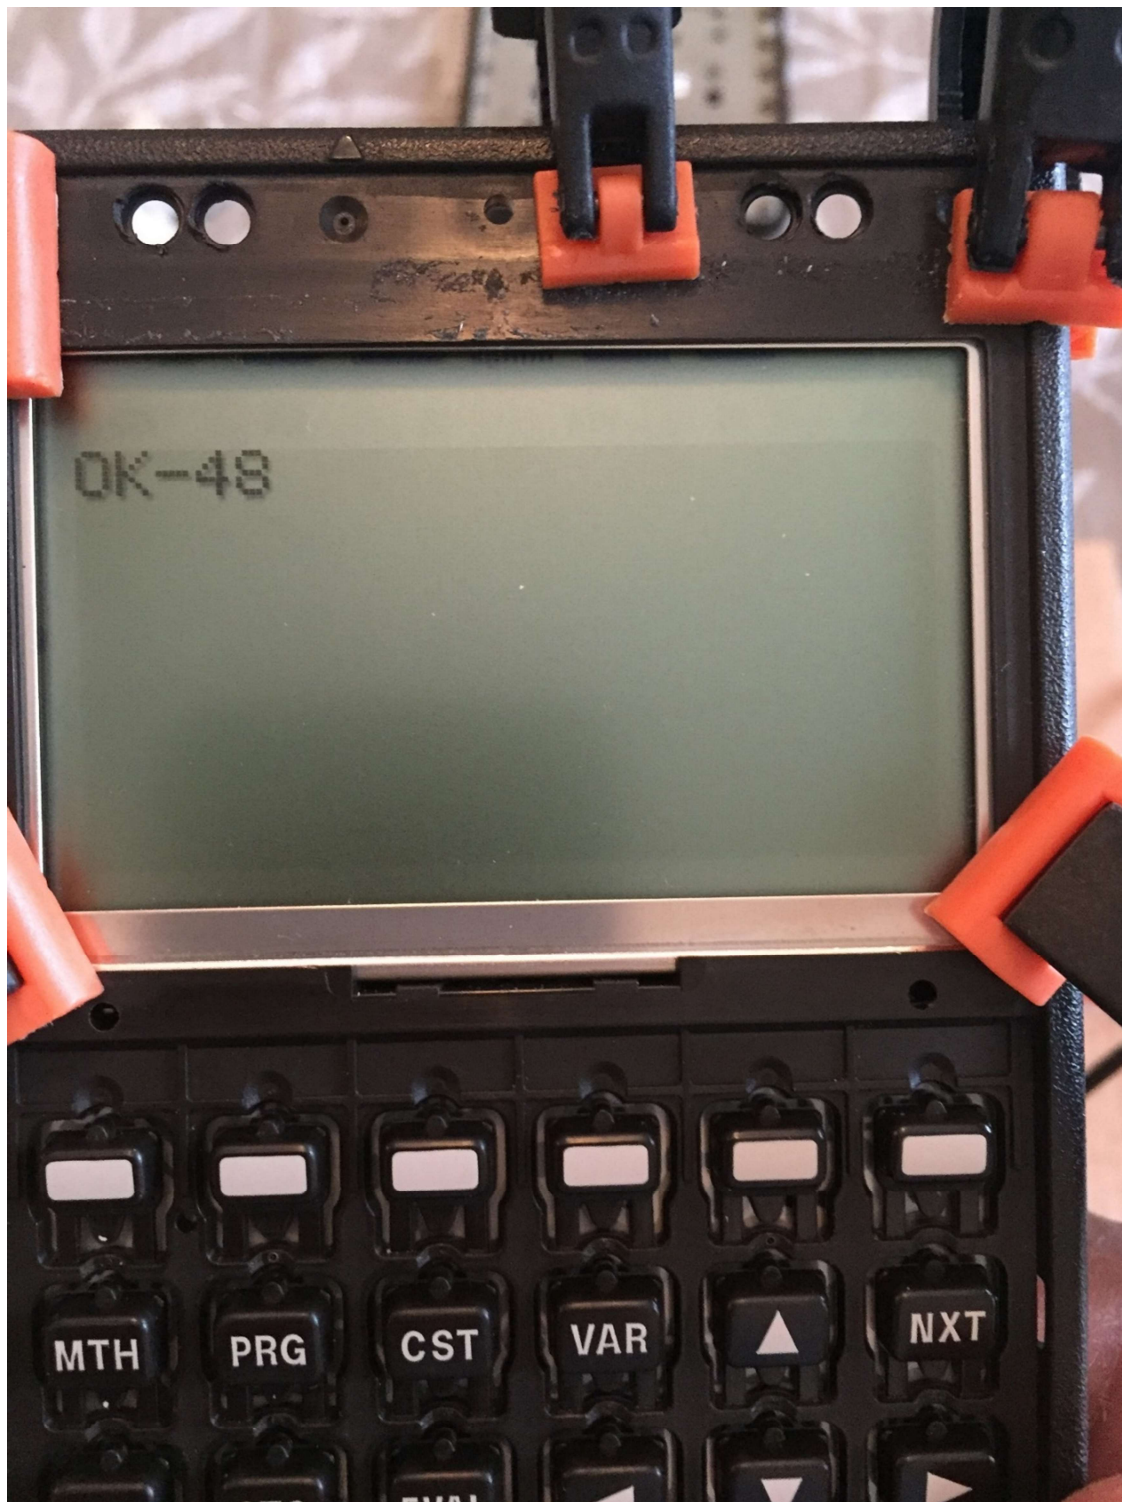
HP 48sx self test passes! I actually verified the IR send/receive, printing, and card slots while the PCB was still attached using the plastic clamps.

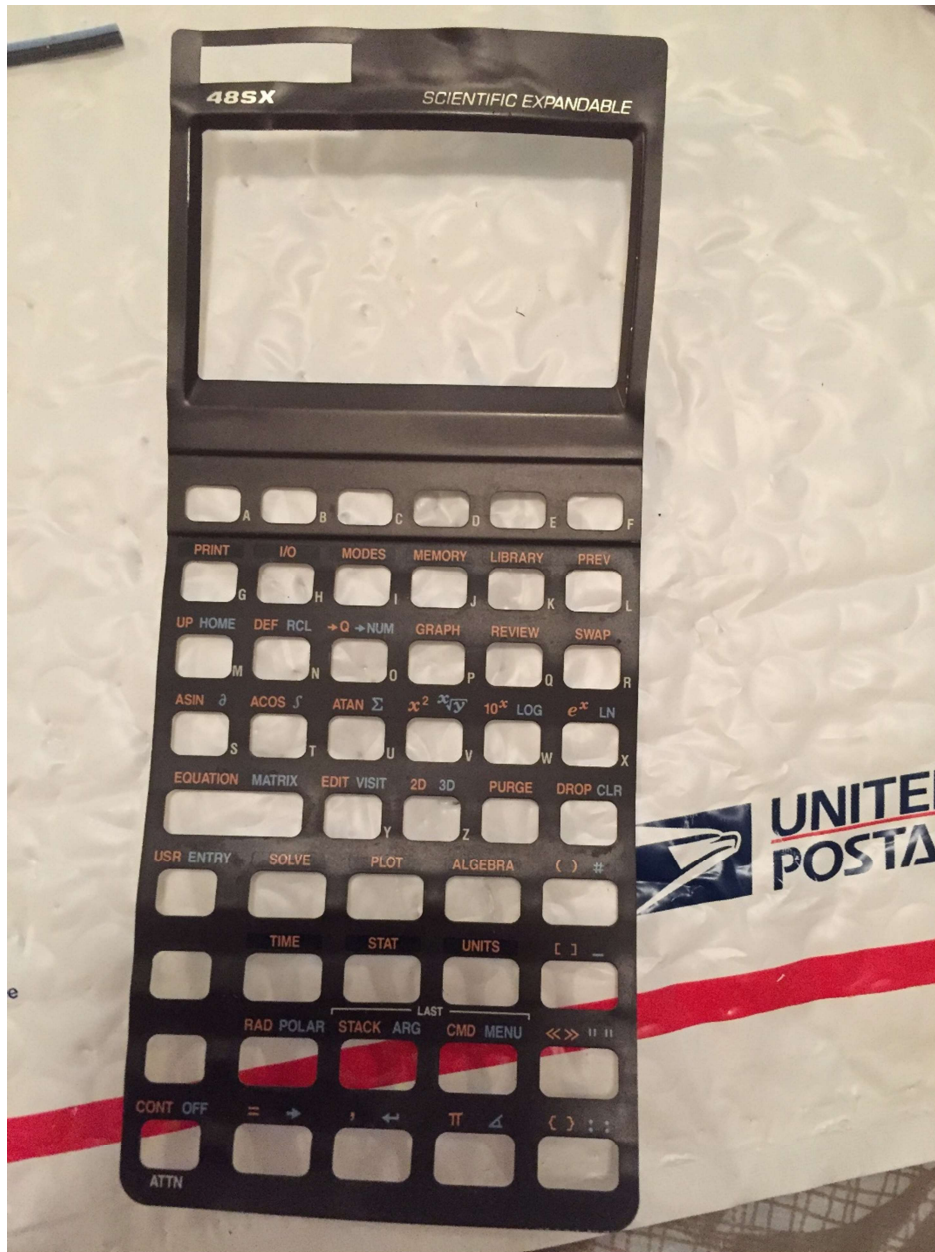
The Metal overlay from the 48sx with the broken keyboard. The top part was very difficult to get loose due to an overzealous glue job from the factory. This will be fun to straighten out again.
